## Minerals Inspection Report

Mine Name: Round Valley Rock	Permit Number: M/029/0006 <sup>4</sup>	Mine Status: Active
Operator Name: Round Valley Rock, Inc.	Inspection Date: 07/31/2013	Permit Fees: Paid
Inspector(s): L. Heppler	Inspection Time: 1:30 PM	Bond Amount: \$67,200
Attendee(s): Rees Family	Weather: Sunny, Dry	Bond Escalation: 08/21/2012
Inspection Purpose: Routine annual inspection		Prior Inspection: 11/30/2010

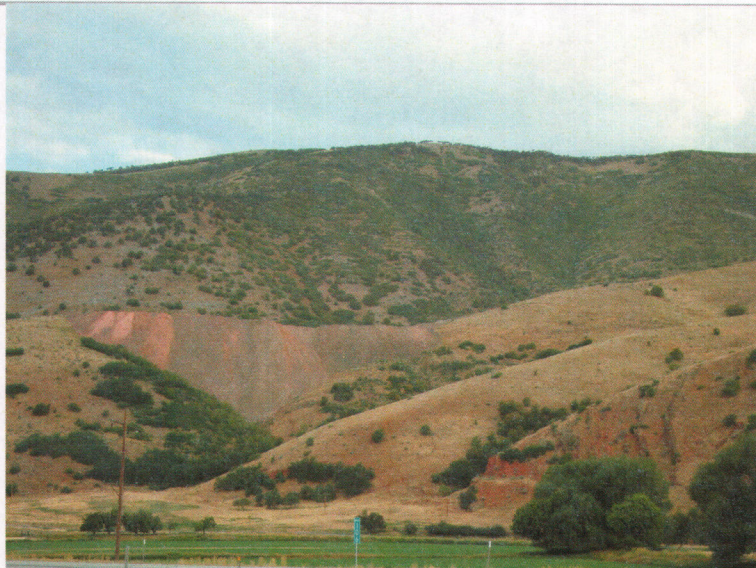
View of site from the valley

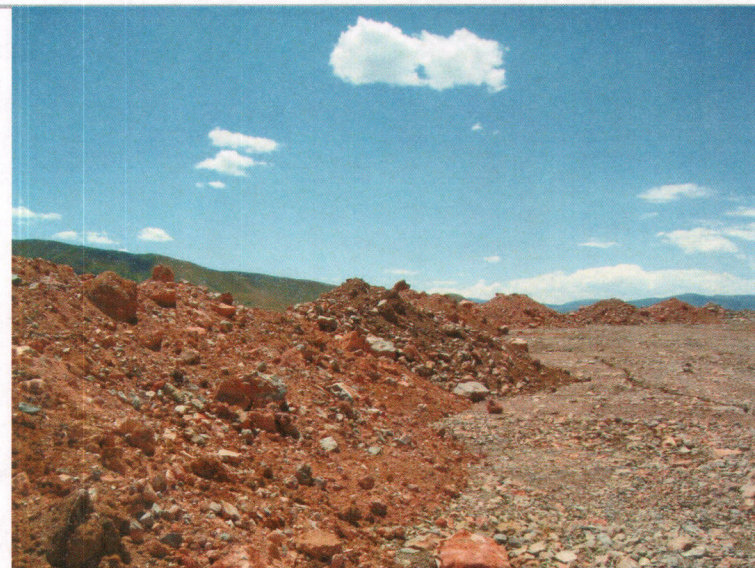
Dump - note head scarp cracking
